From: Stephen Best
To: Flock Safety; Libby Landers; brendon.norton@flocksafety.com; Jake Sherman
Cc: Michael Balcorta; Daniel Cohen; Eligio Lara; Tee Jane Teh; Stephen Best
Subject: And even more failures to read night plates
Date: Friday, May 24, 2024 6:35:38 AM
Attachments: 008 2 hours of cam 134 only 10 plates.pdf
009 2 hours of cam 088 only 80 plates.jpg
001 night read fails 052424 37 percent.jpg
002 night read fails 052424 37 percent ZERO CONFIDENCE.jpg
003 all images cam 001 0512-0514 hrs.jpg
004 all images cam 088 0514-0516 Hrs.jpg
005 all images Cam 090 0515-0518 hrs.jpg
006 all images CAm 028 0516-0519 Hrs.jpg
006 all images CAm 028 0516-0519 Hrs.pdf
007 all images cam 134 0518-0520 hrs.jpg
008 2 hours of cam 134 only 10 plates.jpg

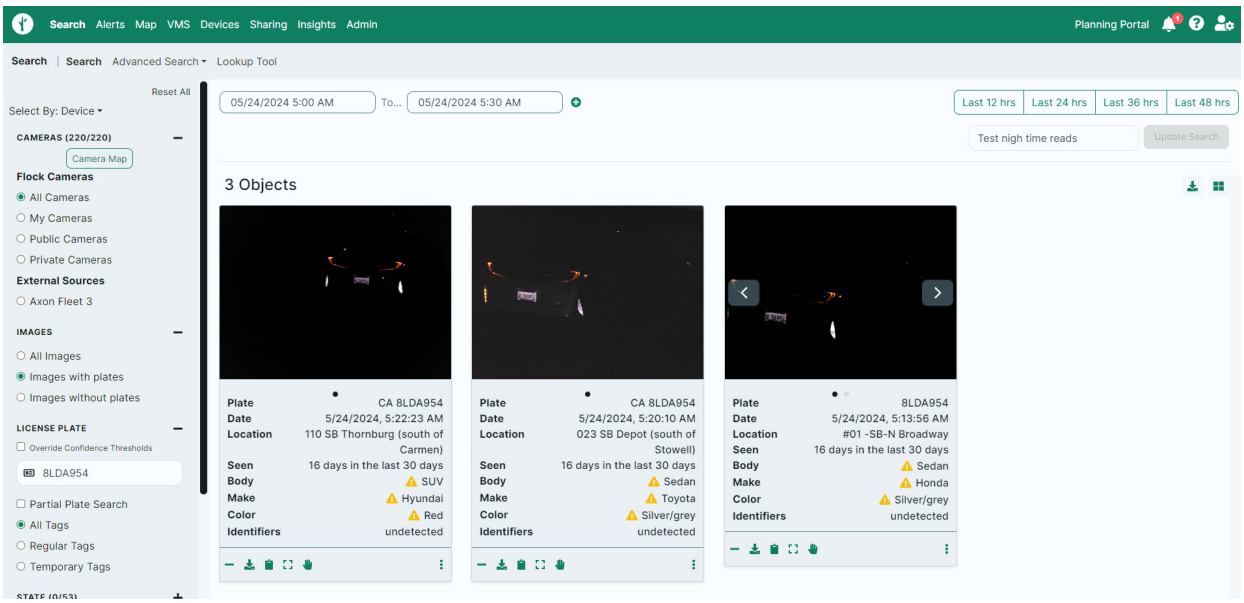
Today's test 05-24-24
CA/ 8LDA954
05:13:19 Hrs. Cam "001 SB Broadway (S of Taylor)" in lane 2 – Failed to read plate
05:14:00 Hrs. Cam "#01 SB N Broadway" (Big America's camera) in lane 2 -Success
05:15:20 Hrs. Cam "088 SB Broadway (S of Orchard)" in lane 2- Failed to read plate (This is on our main thoroughfare!)
05:16:57 Hrs. Cam "090 SB Broadway (S of Chapel)" in lane 2- Failed to read plate (main thoroughfare)
05:17:49 Hrs. Cam "028 SB Broadway (S of Orange)" in lane 2- failed to read plate (main thoroughfare)
05:19:32 Hrs. Cam "134 WB Stowell (W of Thornburg)" in lane 2- failed to read plate (main thoroughfare)
05:20:10 Hrs. Cam "023 SB Depot (S of Stowell)"- Success
05:22:23 Hrs. Cam "110 SB Thornburg (S of Carmen)" -Success

I searched all 220 cameras for 8LDA954 for 05-24-24 from 0500-0530 Hrs. Results=3 successful reads

Please add all these cameras to the list to be serviced.
